35' ROTARY FURNACE REPAIR

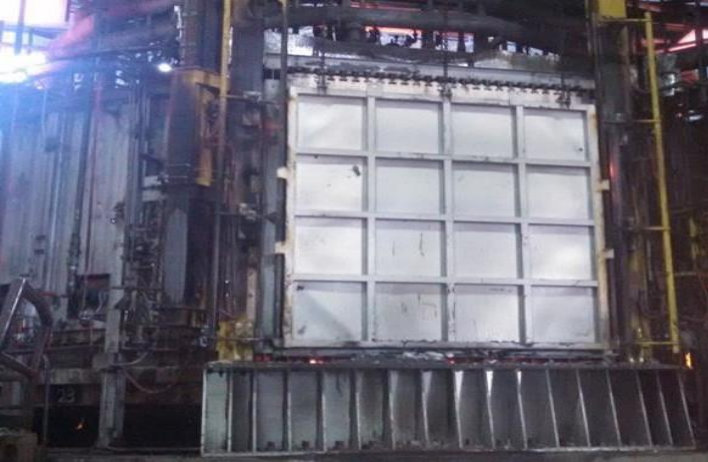
(Above: Furnace with discharge door closed /
Right: Inside with completed repairs)

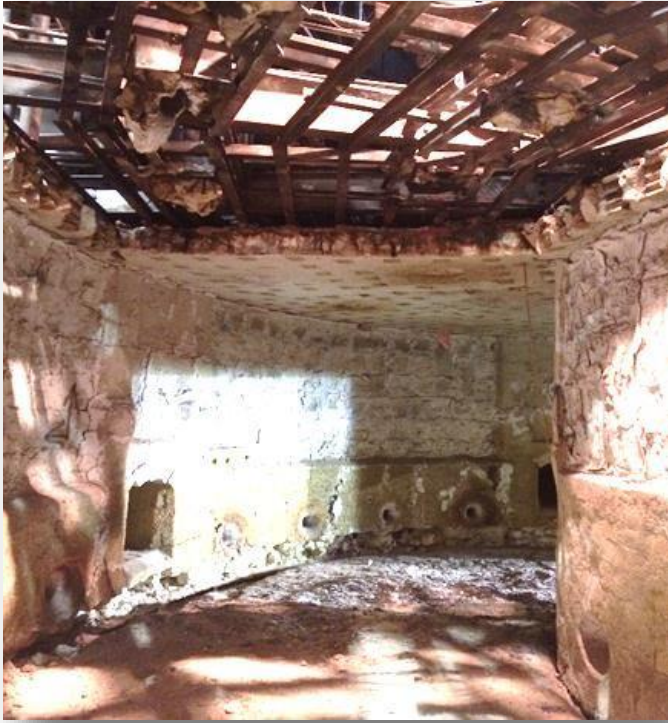
Left: Inside furnace highlighting damages to hearth floor, flues, sidewalls and roof.

Additional scope consisted of: rebuilding flues, chipping scale from floor, 100% new refractory sidewalls, wall burner replacement, wall burner repair, repair to structural roof, shoring & reinstalling new inner buckstay supports, and a new hearth floor.

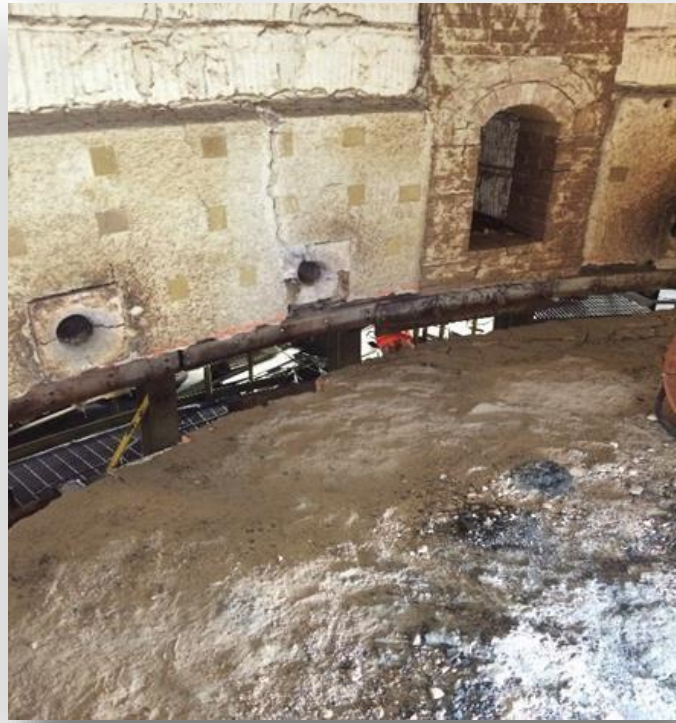
Right: Shown with wall castings, water troughs, retaining ring and water seal blades removed.

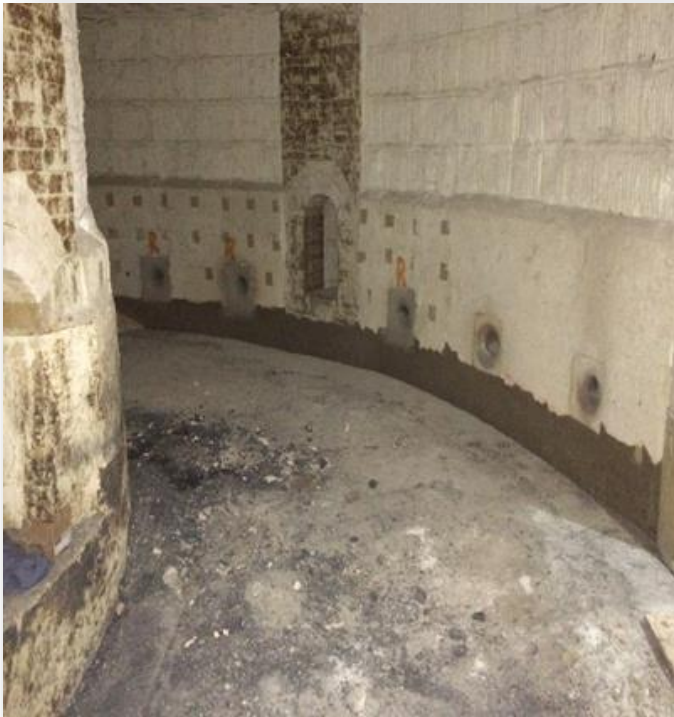
Left: Repairs to hearth and lower wall after installation of new wall castings and water troughs.

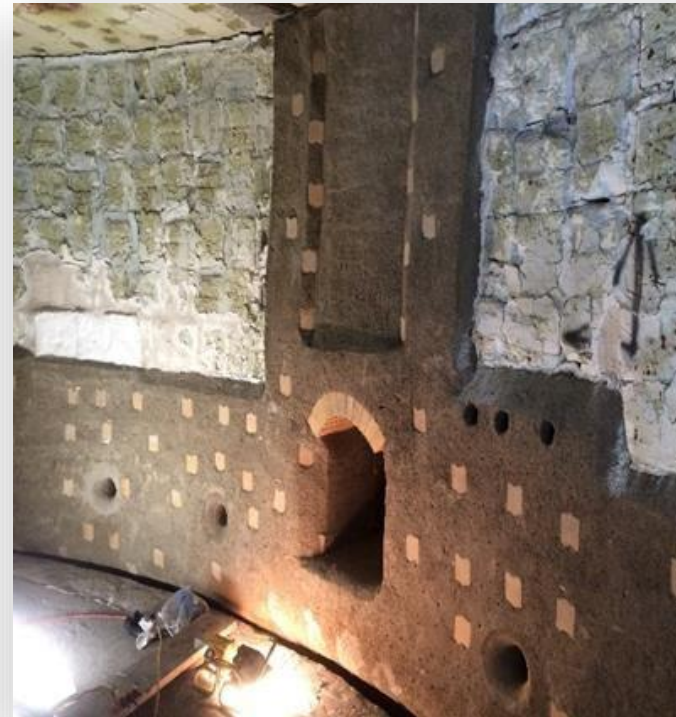
Right: New flue, perimeter sidewall and hearth floor.
