TUNNEL KILN ENGINEERING STUDY

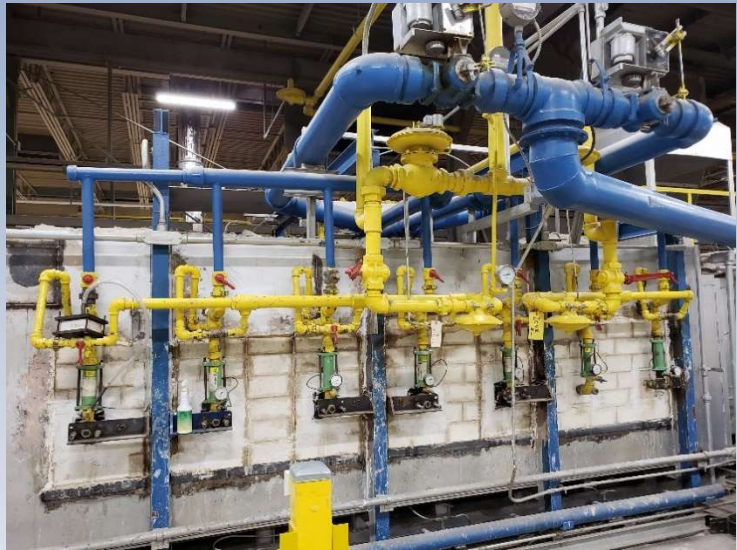
During the investigation, we found that the kiln utilizes burners that are likely original to the kiln. They do not have spark ignition, meaning they must be lit by manually lighting a starter flame inside the kiln. This means that the kiln is empty during light up, leaving an escape route through the bottom of the furnace for the excess gas from the burner. After researching modern burners and performing combustion calculations, we wrote a report recommending that the client replace at least 4 of the existing burners with new modern burners that recirculate excess products of combustion rather than releasing them into the kiln. The modern burners can also be spark ignited from outside the kiln, allowing the kiln to be filled with its insulated carts during light up, effectively sealing the escape route. By recirculating the excess gas and insulating the bottom of the kiln, the client would be able to reduce their gas leak to a safe level to resume operation of the kiln.

In addition, we provided information and pricing estimates for the replacement burners, further upgrades to the combustion system and controls to meet today's NFPA 86 safety standards, and all installation costs for the system upgrade. While the client decided not to immediately complete the upgrade, they are now armed with enough information to budget for a future upgrade when the need arises to return the kiln to operation.
