# GALBESTOS REMOVAL & HELICOPTER LIFT

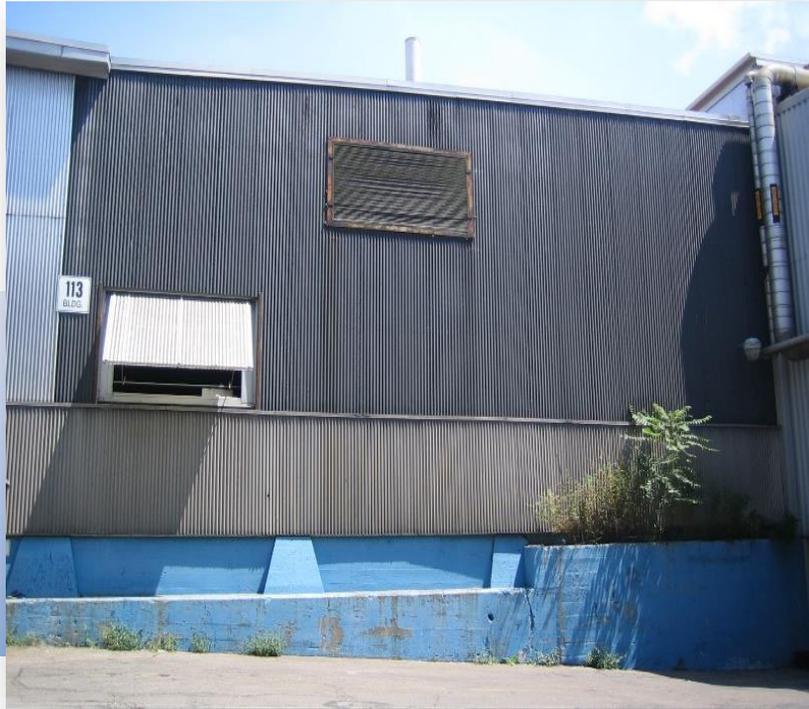
*Galbestos coated siding*

PTS provided support for the removal and replacement of approximately 2,000 square feet of siding coated in Galbestos. Temporary weather proofing was provided after the removal of the old siding, prior to the installation of the new siding. All siding removal required a regulated area, air sampling, and contractors trained in asbestos handling.

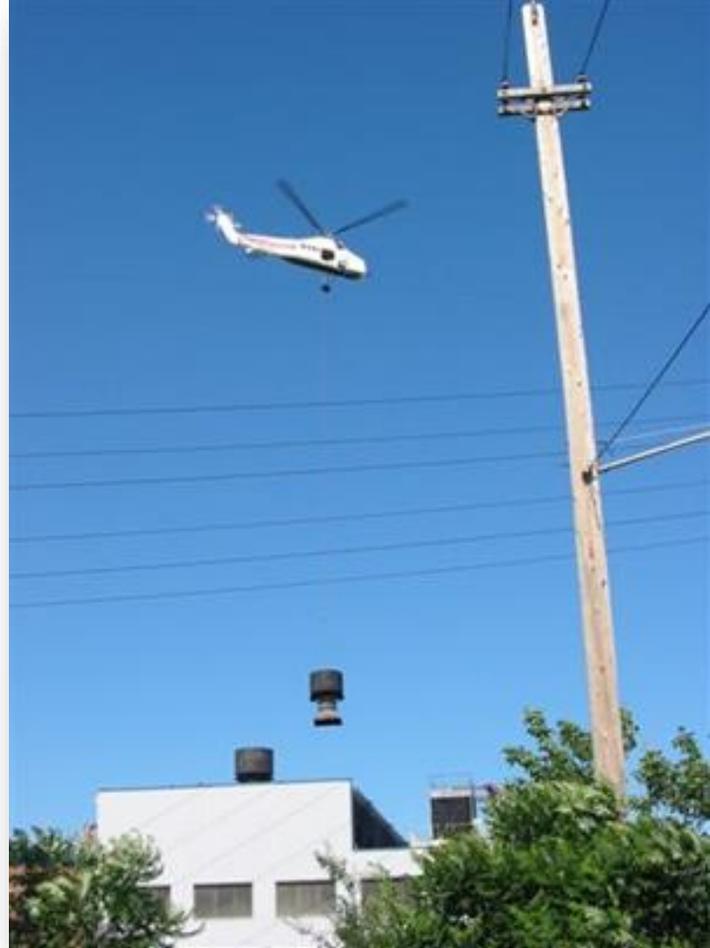
*Above: Helicopter removing a vent. Below: New vent to be installed.*

15 of the vents were extremely close to the street. PTS determined removing the vents with a helicopter would be quicker and more cost effective than a crane. The helicopter lifts required the street to be closed for part of the day. PTS worked with the clients and the surrounding businesses to determine the best days for the street closures. Once the closure dates were determined, PTS worked with the local police department to close off the street.
