MAKE UP AIR AND NEW CONVEYOR

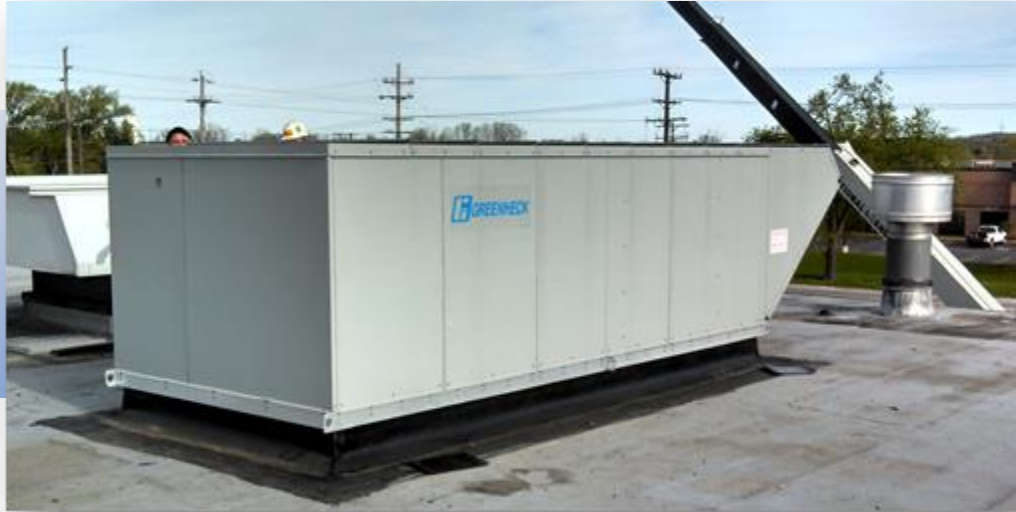
Problem: Product was not cooling properly thus leading to quality issues. PTS determined the cause of quality issues installed a new cooling conveyor.

Solution: After investigating possible causes, an air balance was completed and results determined that there was not enough air being returned to the roasting room to replace the air being removed by all the exhaust fans for the roasters and cooling conveyors. A new Makeup Air unit was sized to supply the current shortage of air and included enough for planned upgrades to the roasting room. Then the roof was analyzed to confirm that it would support the weight of the new unit.

A new cooling conveyor was also designed for the production line that was suffering the worse of the quality issues. The new

conveyor pulls air through the product, more efficiently cooling the product as compared to the previous design. Removal of the existing conveyor, installation of the new conveyor, roof penetration and ductwork install had to be scheduled around production that runs 6 to 7 days a week.
