GALBESTOS REMOVAL & HELICOPTER LIFT

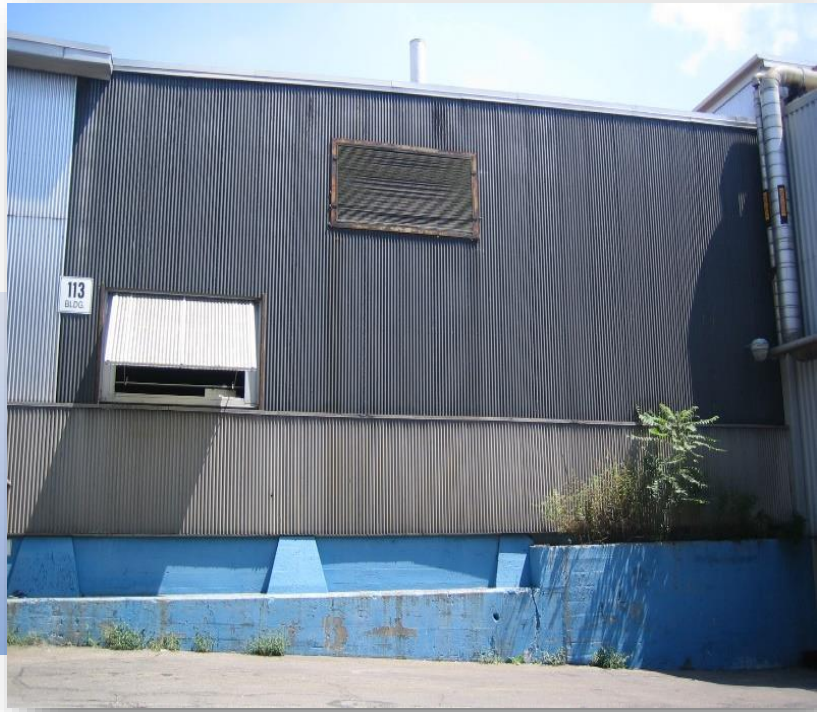
Galbestos coated siding

PTS provided support for the removal and replacement of approximately 2,000 square feet of siding coated in Galbestos. Temporary weather proofing was provided after the removal of the old siding, prior to the installation of the new siding. All siding removal required a regulated area, air sampling, and contractors trained in asbestos handling.

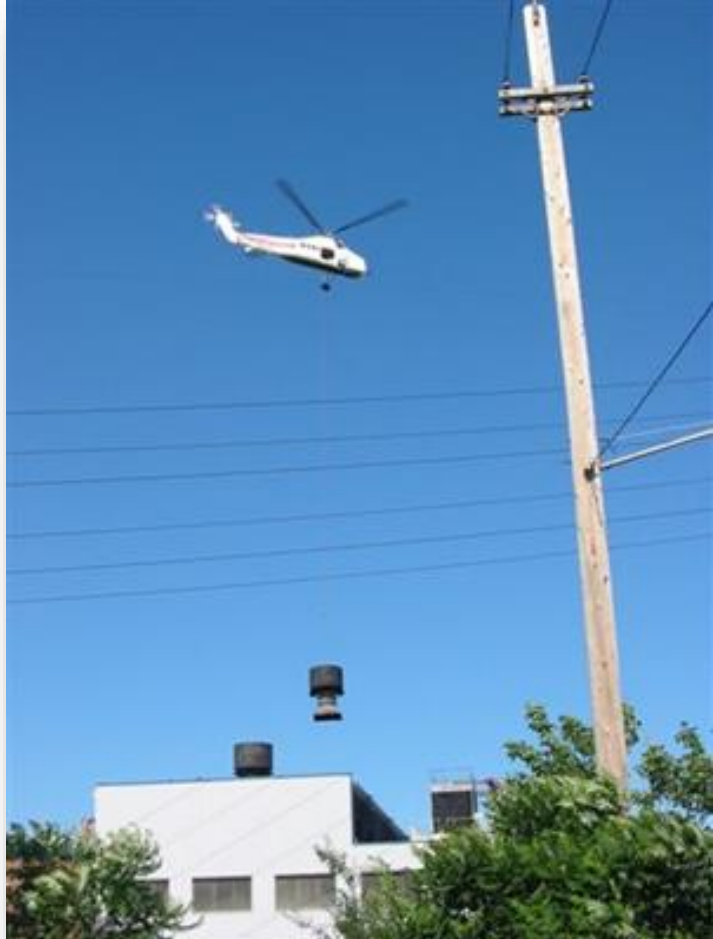
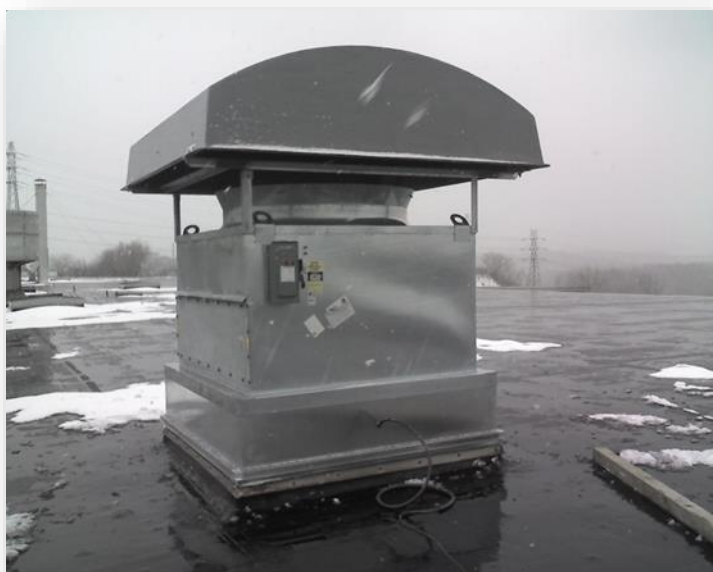
Above: Helicopter removing a vent. Below: New vent to be installed.

15 of the vents were extremely close to the street. PTS determined removing the vents with a helicopter would be quicker and more cost effective than a crane. The helicopter lifts required the street to be closed for part of the day. PTS worked with the clients and the surrounding businesses to determine the best days for the street closures. Once the closure dates were determined, PTS worked with the local police department to close off the street.

Again, PTS worked with the local authorities to close the road for the second helicopter lift. This lift was scheduled, in advance, to accommodate the production schedule of the customer and the surrounding businesses. The second lift was used to install the new 15 vents, replacing those removed during the first lift.
