Metal Grinding Booth Upgrades

Plant Engineering

Metals

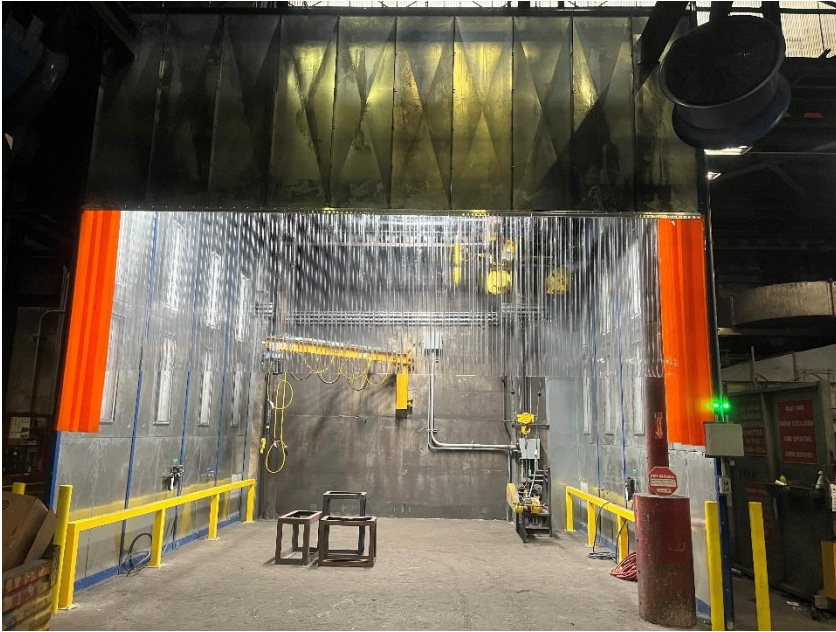
The final product was an updraft booth and new dust collectors, providing higher air flow velocities. Productivity could increase and maintenance downtime could decrease because of inspection brightness lighting, a new underhung crane hoist, a wall mounted jib crane, and improved swing grinders.
