LIQUID NITROGEN SYSTEM

New liquid nitrogen tank

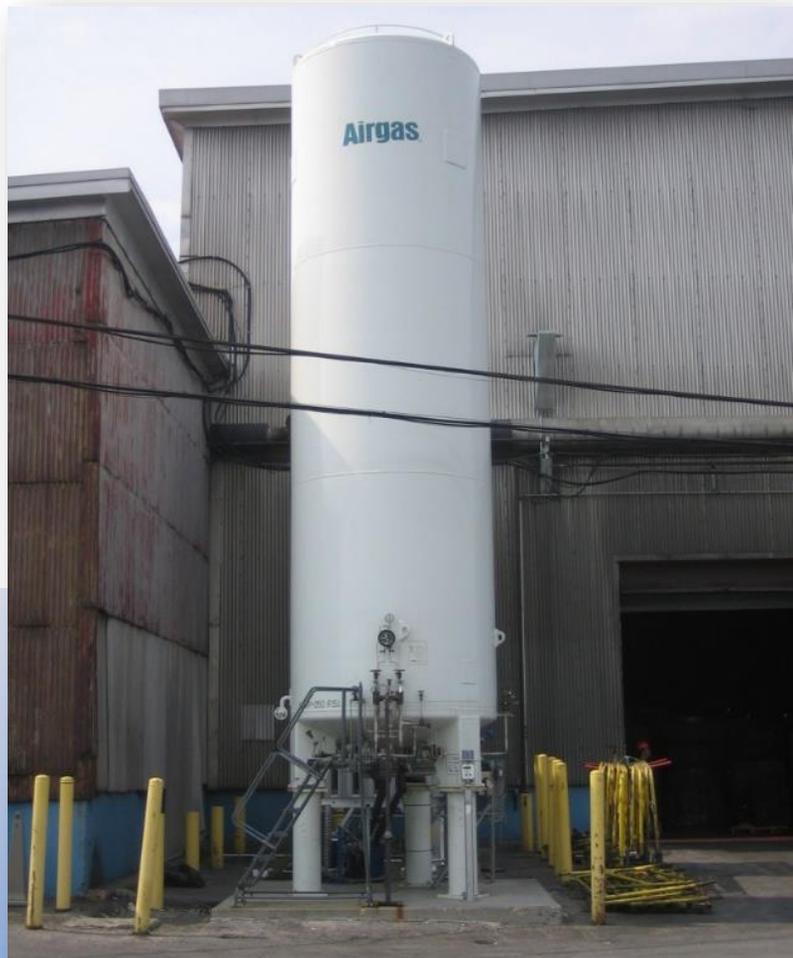
Solution: The customer wanted to refill the tanks much quicker than the existing compressor and more cost effectively than utilizing a liquid nitrogen truck. In summary, a new liquid nitrogen system was installed onsite. The new liquid nitrogen system included a 6,000-gallon liquid nitrogen tank, a high-pressure compressor, and a vaporizer.

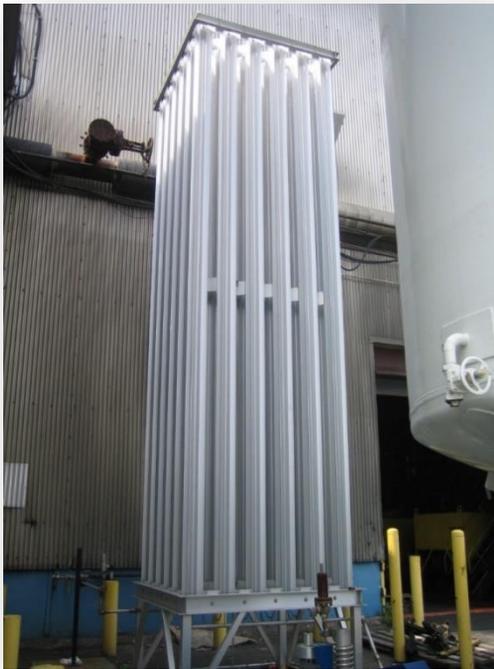
New vaporizer

The new tank, compressor, and vaporizer were installed on top of the new foundation. These pieces of equipment were piped to the existing compressed air tanks.
